# ANIMO

Possible loose glass panels Optibean Touch machines.

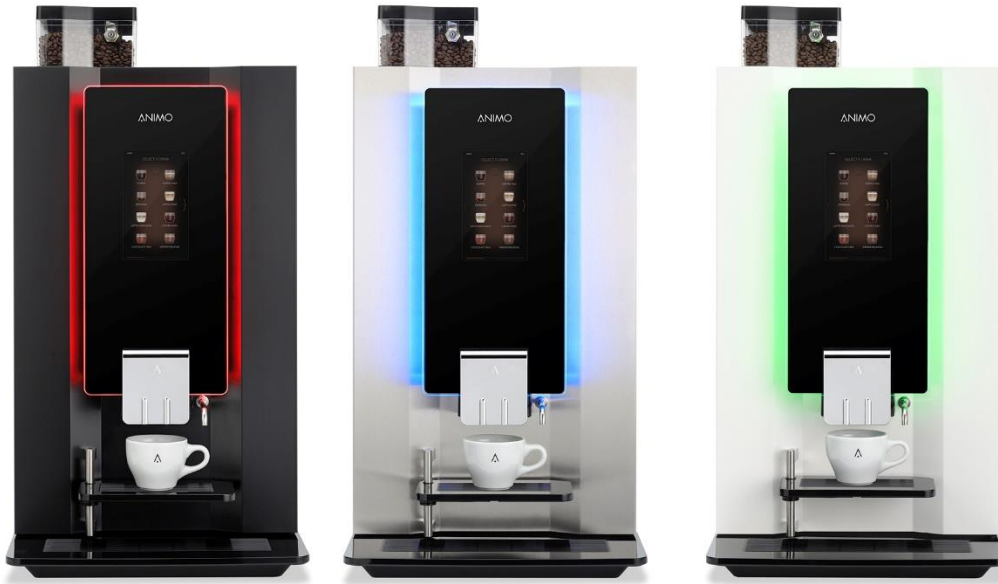
Problem description:

Due to tolerances in the different materials it may occur that a glass panel will loose from the Optilight panel.

A narrow gap will be visible at the top of the cover glass it will never fall off entirely.

A permanent solution for these problem is in progress, a temporarily solution is described on the next pages:

Temporarily solution:

Follow the next steps to solve the occurred problem.
